# New York State Department of Transportation

## Yellow Flag NB2228W007

Flag Date: March 18, 2022

**BIN: 1065318**

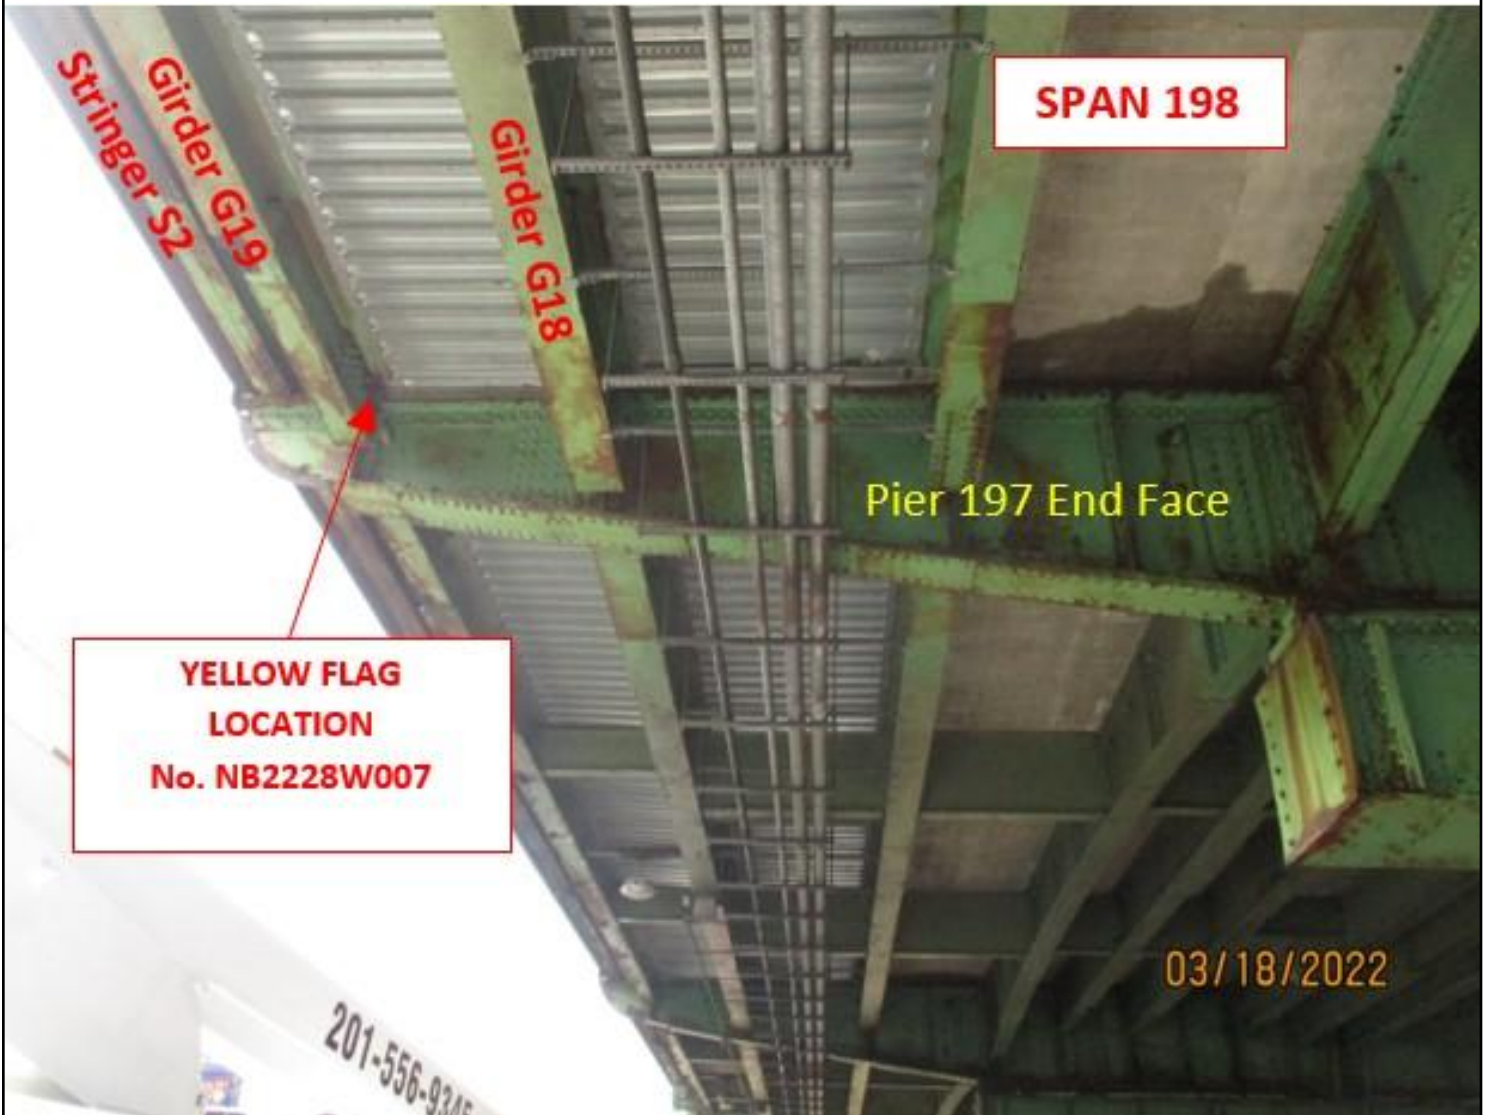
Photo Number: 1

**Attachment Description:** Span 198, Girder G19 at Pier 197. General view of crack location at pier cap connection. Looking begin.

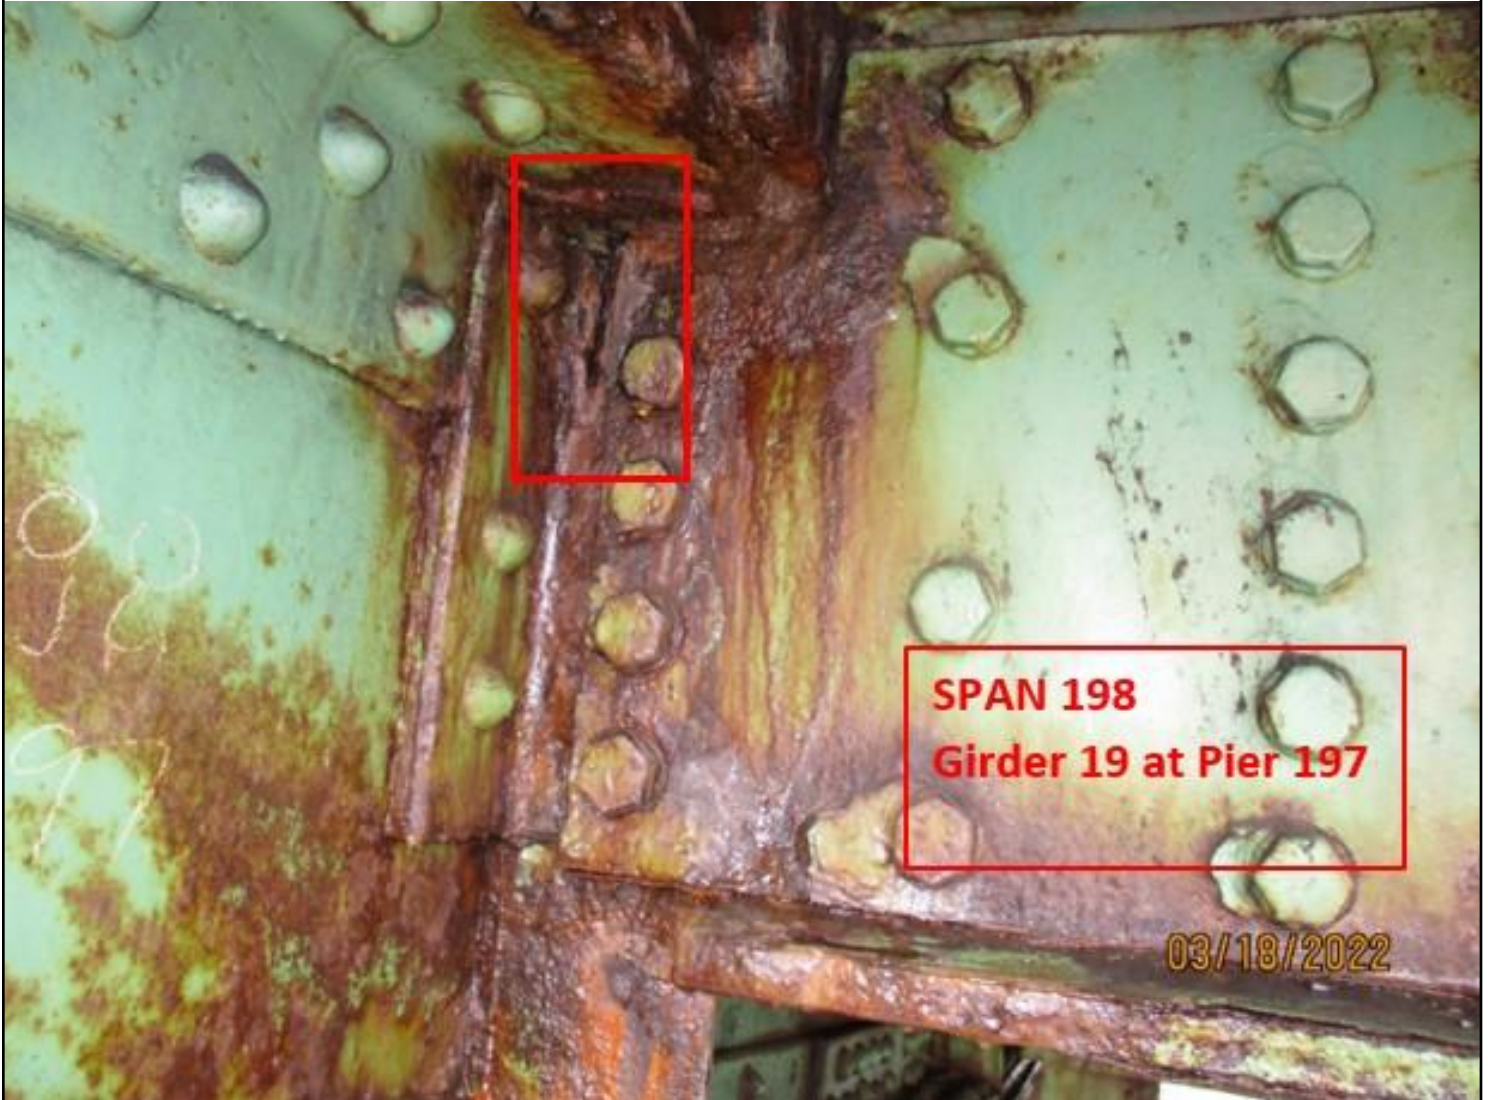
Photo Number: 2

**Attachment Description:** Span 198, Girder G19 at Pier 197. General view of the flagged location showing severe corrosion and cracking in the right connection angle of the girder to the pier cap. Looking begin-left.

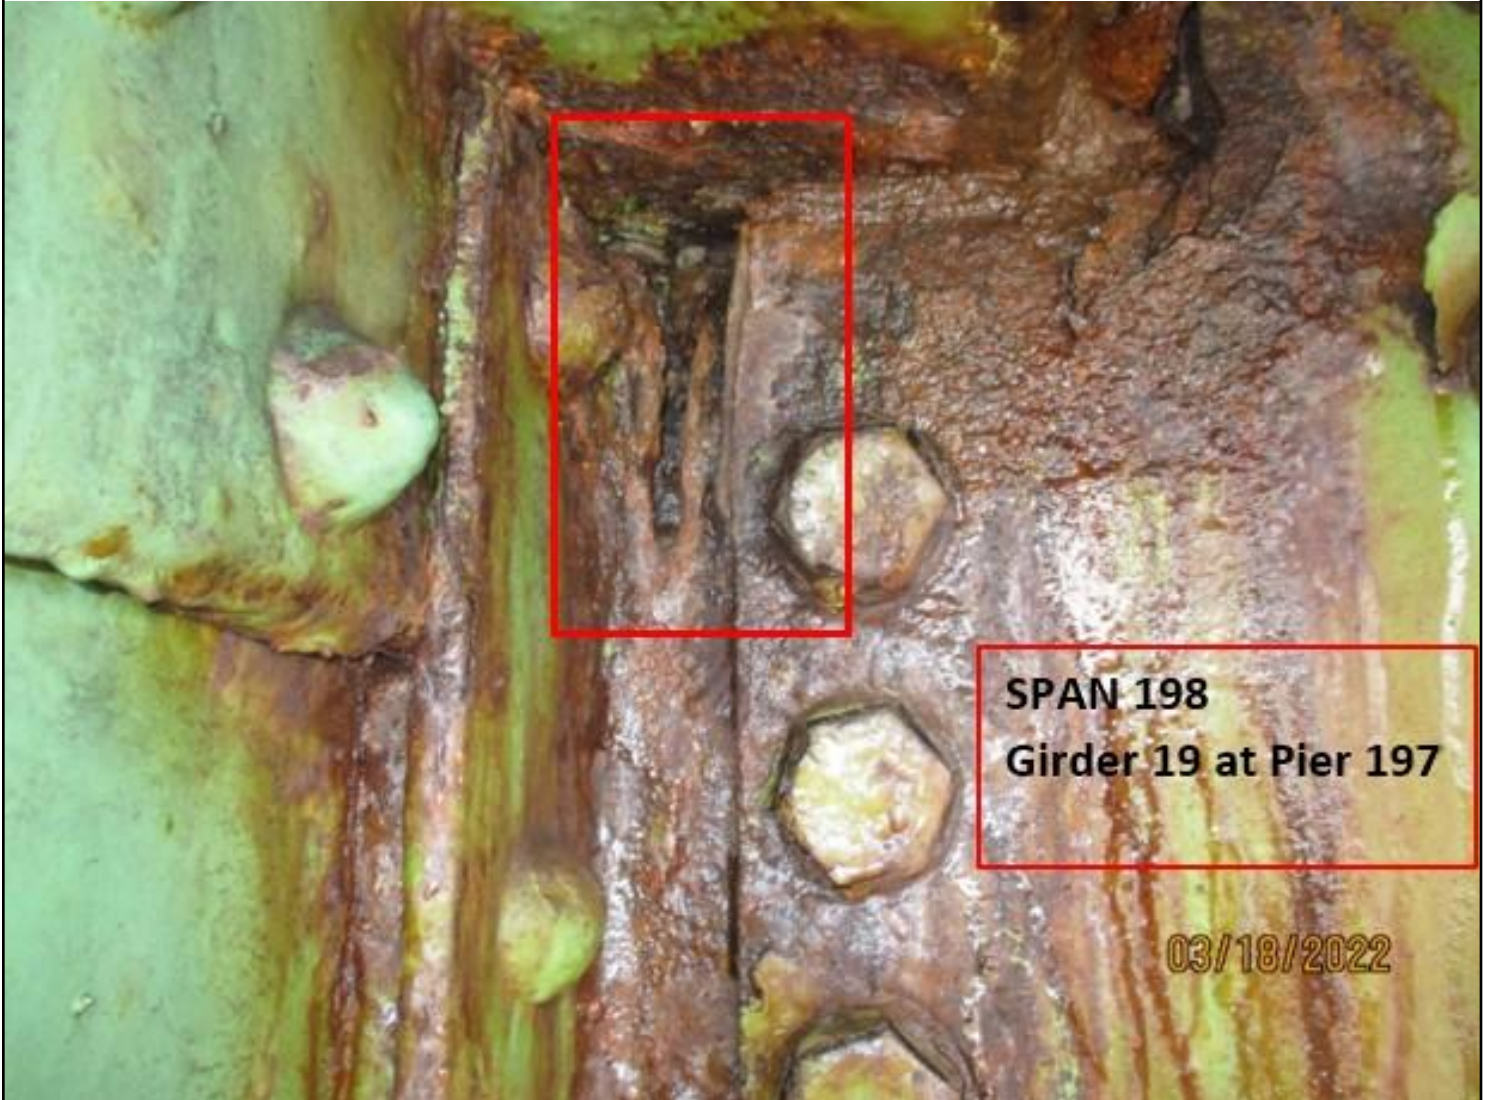
Photo Number: 3

Description: The right clip/connection angle of Girder G19 connection to the end face of the pier cap at Pier 197 exhibits a 3-1/2" long vertical crack x 3/8" wide at the upper fillet section (deterioration induced cracking, no change from the previous inspection). The remaining section of this clip angle has heavy corrosion with up to 3/16" section loss. The left side stiffener connection angle has a 2" long x 1/8" wide vertical corrosion crack at the upper section (not previously noted), at the connection to the pier cap. Other than as noted, there has been no significant changes to this flagged condition.

**Attachment Description:** Span 198, Girder G19 at Pier 197. Close-up view of the flagged location showing a 3-1/2" long vertical crack x 3/8" wide at the upper fillet section. Looking begin-left.

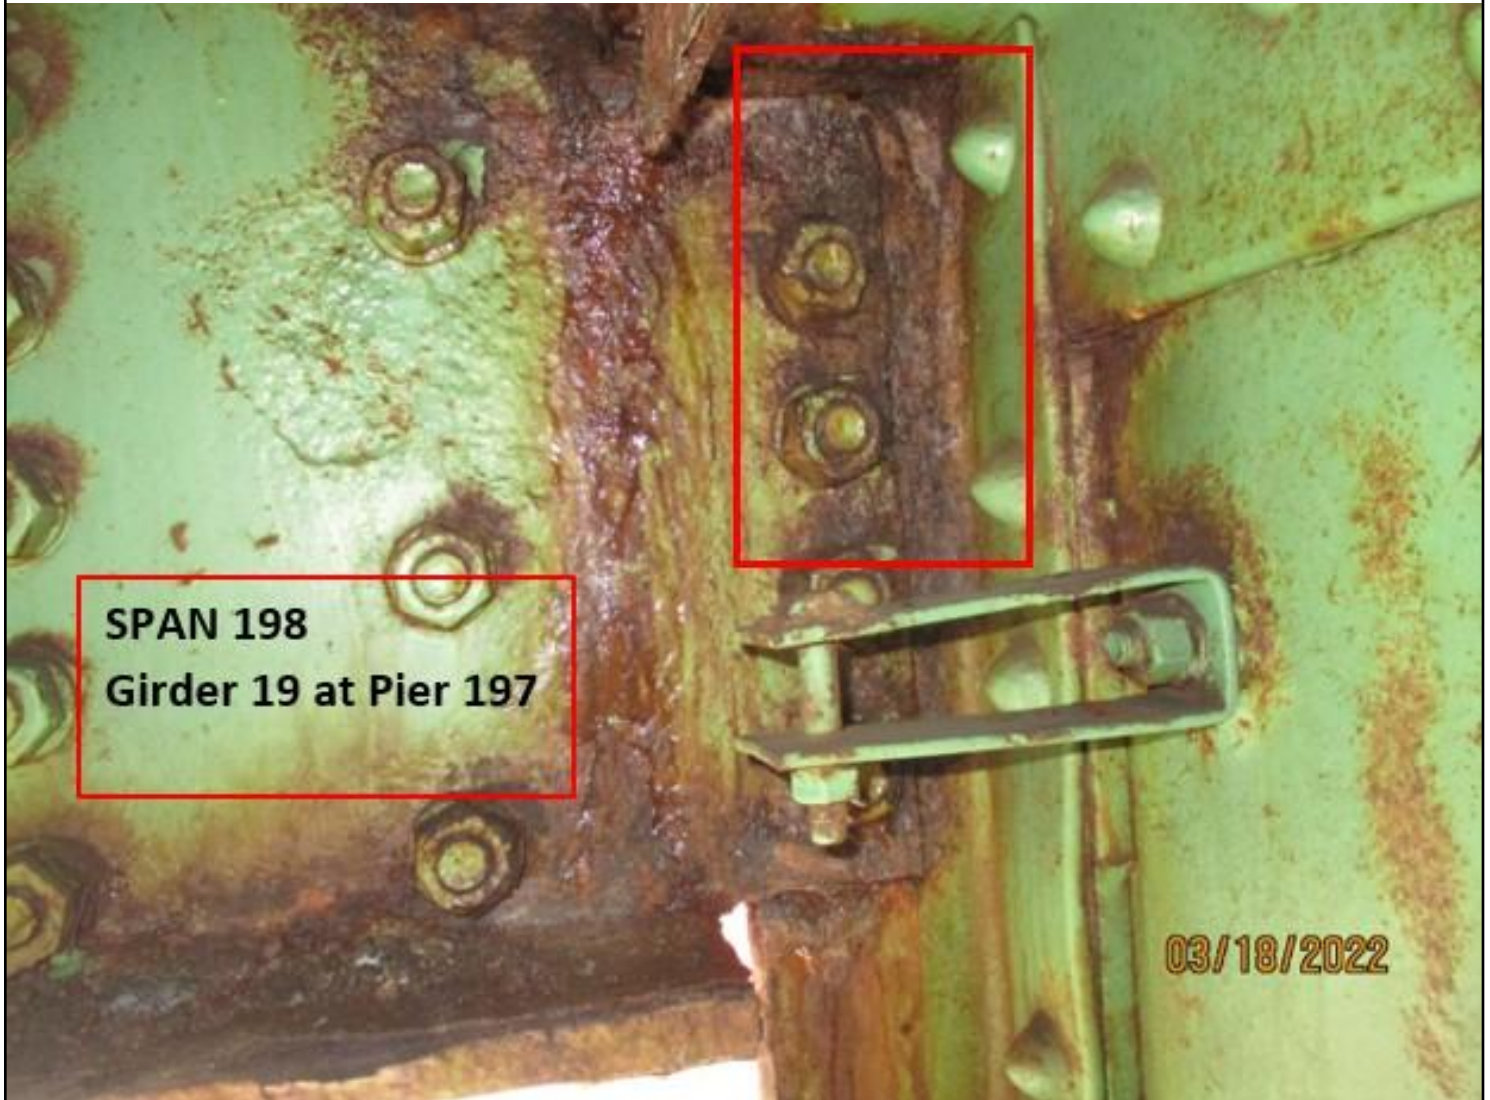
Photo Number: 4

**Attachment Description:** Span 198, Girder G19 at Pier 197. General view of the flagged location showing severe corrosion and cracking in the left connection angle of the girder to the pier cap. Looking begin-right.

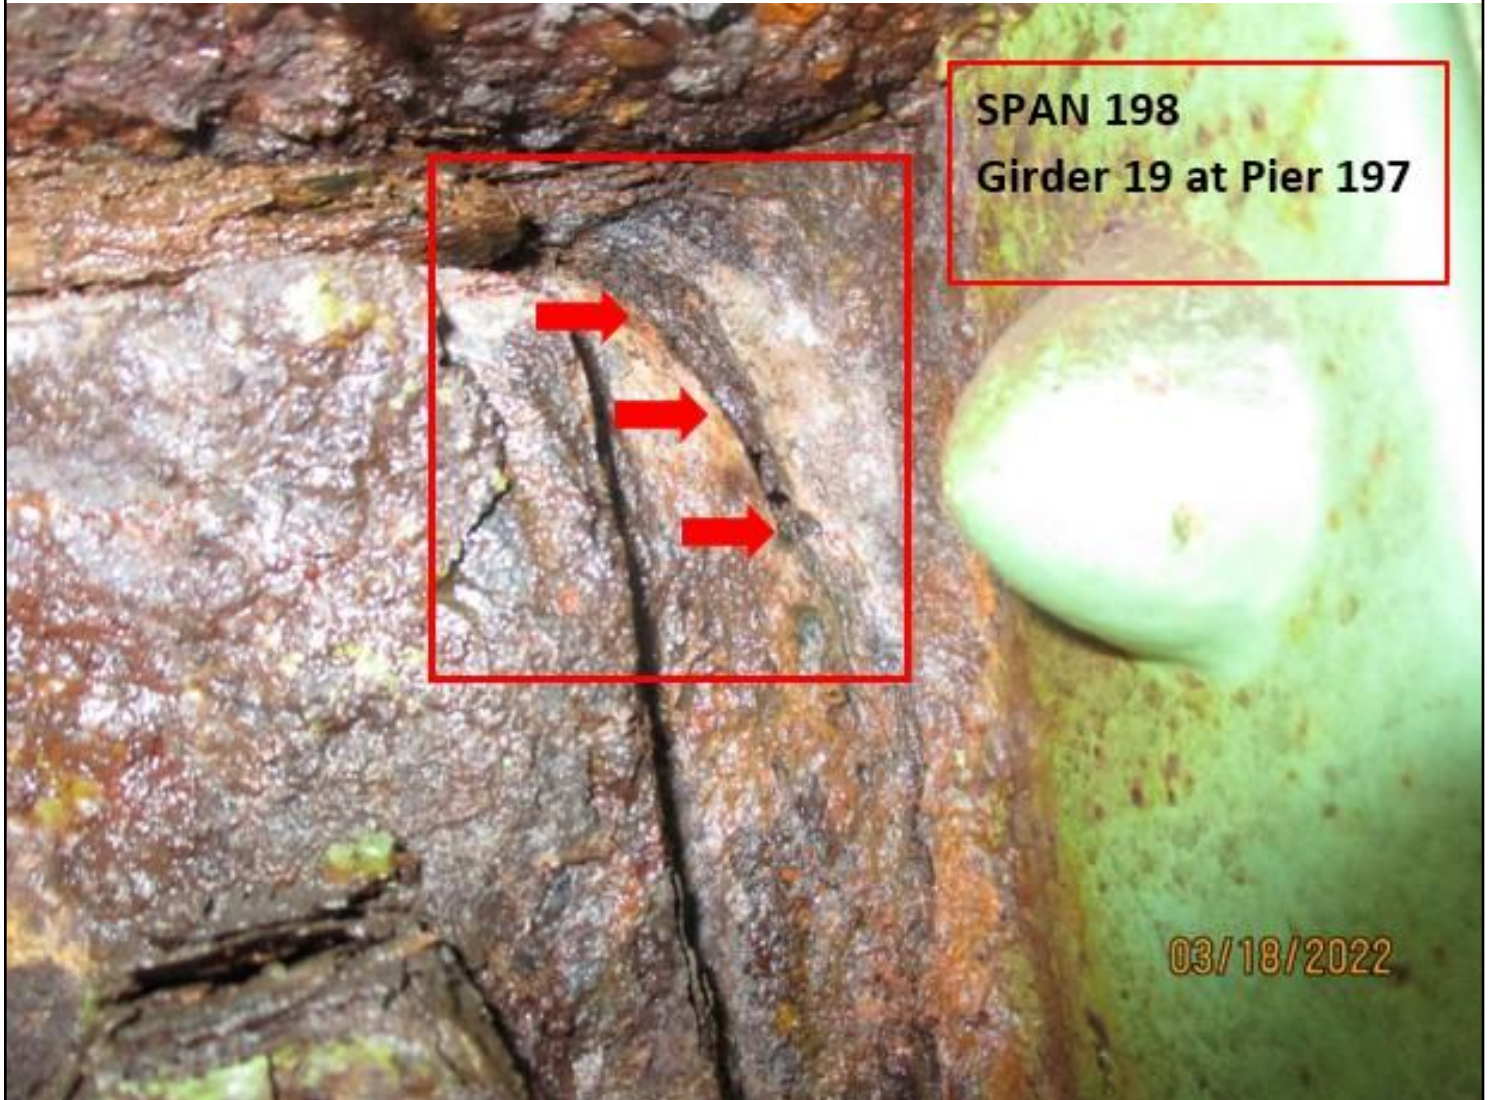
Photo Number: 5

**Attachment Description:** Span 198, Girder G19 at Pier 197. Close-up view of the flagged location showing a 2" Long x 1/8" wide vertical crack at the upper section in the left connection angle of the girder to the pier cap. Looking right.
